# **Tree Report**

Elmwood

Milpitas CA

March 2004

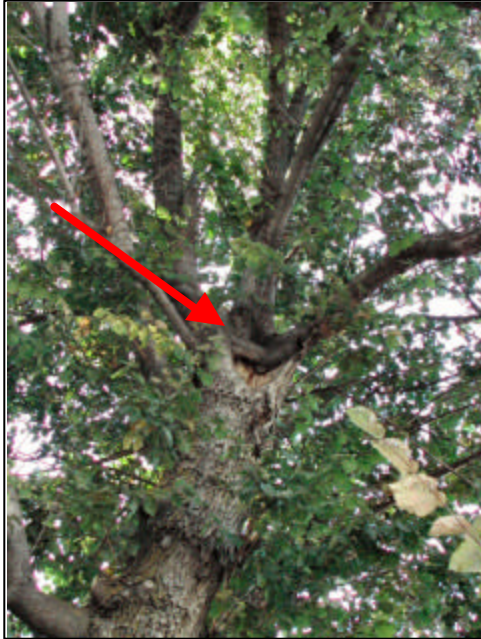
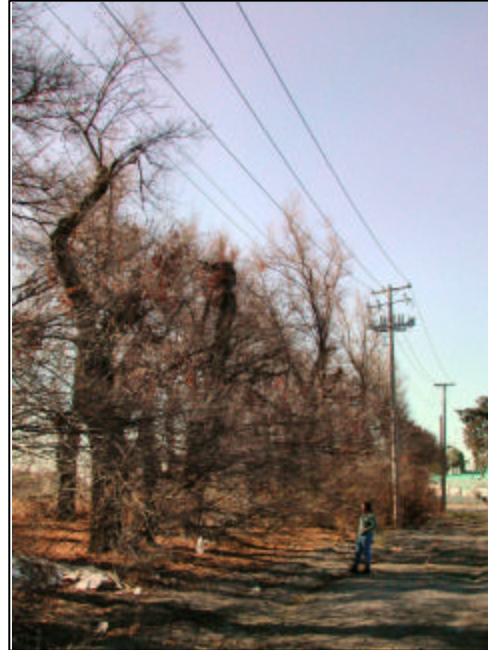
All of the 55 trees had been topped many years ago. Large lateral branches were either removed or cut to large stubs. There was extensive decay at the topping point as well as at old pruning wounds and sites of branch failure (see below left, red arrow). Sprouts that developed following topping were 6" to 10" in diameter. A set of utility lines paralleled the northside of the planting (see photo, below right). Trees on this side had been trimmed to provide clearance and were generally smaller in diameter with asymmetric crowns.

All of the elms were in poor condition. Dieback of twigs was common. For trees #204, 206, 214, 234, 242, 244, and 248, dieback extended into the main trunk. These trees were little more than a decay trunk with a few small sprouts.

Failure of branches and stems was common. We observed branches that had failed at the point of attachment to the stem as well as due to heavy weight. Several stems failed just below the topping cut. Decay was so extensive that the upper stem, where most of the branches were attached, simply broke off.

Included in the recommendations for removal are the 55 trees in the historical elm grove. In my view, the proposed use of the area around the trees is incompatible with the existing resource due to the very high potential for tree failure. As noted previously, the elms have poor suitability for preservation and a strong history of failure. To invite people to use the area beneath these trees would be inappropriate.

I reiterate that our recommendation is to remove and replace all of the elms.
